# **INDOOR AIR QUALITY ASSESSMENT OF PROPOSED OFFICE SITE FOR ESSEX COUNTY REGISTRY OF DEEDS**

**45 Congress Street  
Shetland Park  
Salem, Massachusetts 01970**

Prepared by:  
Massachusetts Department of Public Health  
Bureau of Environmental Health  
Indoor Air Quality Program  
April 2008

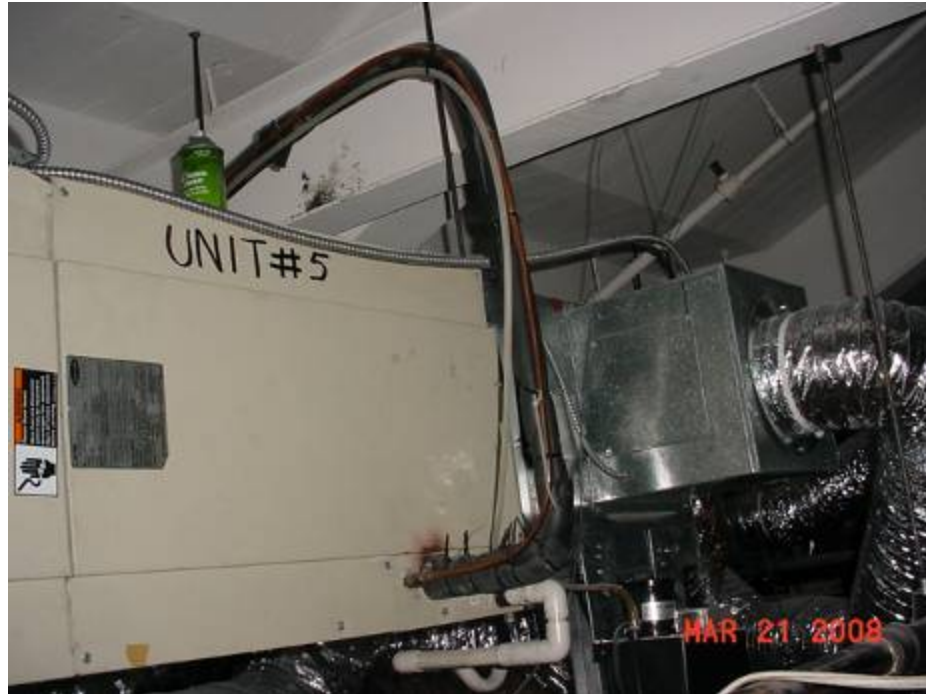
**Picture 1**

Air-handling units (AHUs) provide fresh air to the office space. AHUs are electrically powered and located within the ceiling plenum of the building (Pictures 1 and 2). These units appear to be operating normally; however, water-stained ceiling tiles were observed beneath the AHUs.

Several areas had water-damaged ceiling tiles which can indicate sources of water penetration (Table 1). Water-damaged ceiling tiles were observed under the AHUs and within the loading dock area adjacent to the office space. Water-damaged ceiling tiles were also noted in a hallway and a restroom. Water-damaged ceiling tiles can provide a source of mold and should be replaced after a water leak is discovered and repaired.

**AHU in Ceiling Plenum**

1. Remediate the water damage noted and replace ceiling tiles.
2. Clean the space with a HEPA filter vacuum prior to occupancy.
3. Provide adequate amount of time to ventilate the office to remove residual renovation odors.
4. Refrain from opening windows to prevent vehicle exhaust entrainment.
5. Examine options to prevent water penetration through the access door.

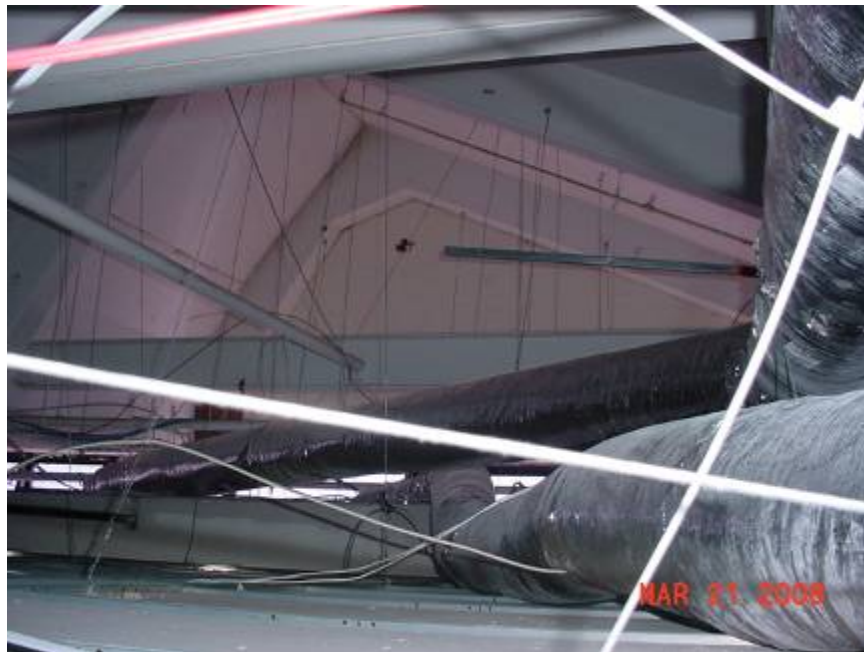
**Picture 2**

**Ductwork above Ceiling**

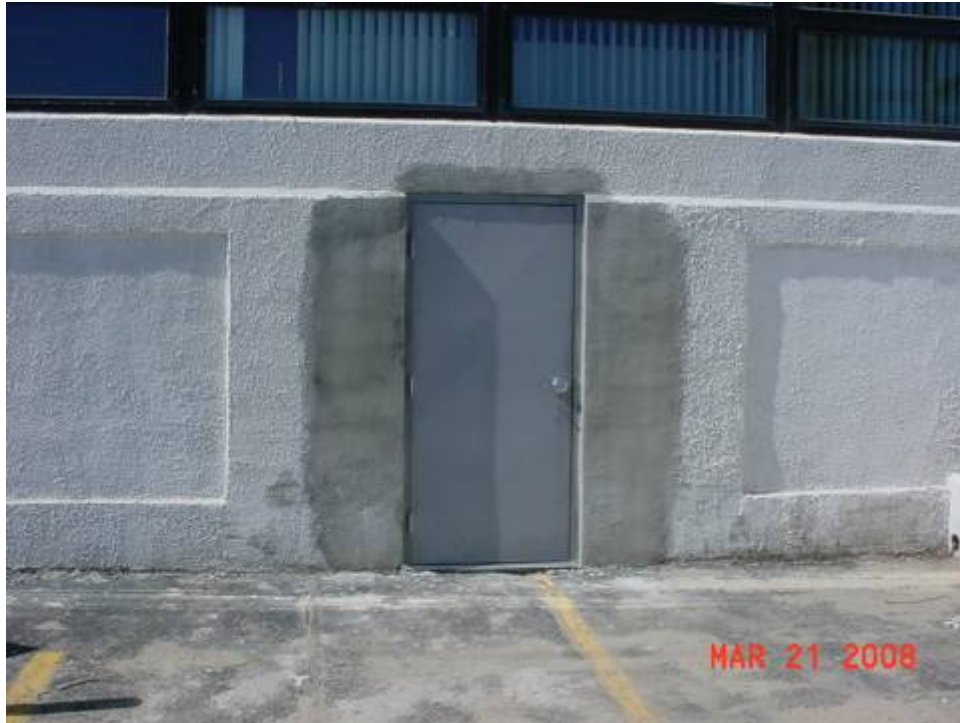
**Picture 3**

The front of the building contains a newly installed exterior door providing access to the building for the disabled (Picture 3). The threshold of this door (Picture 4) should be configured to prevent water penetration through the door frame during periods of wind-driven rains. Install weather stripping around exterior doors to prevent drafts, water penetration and pest entry.

**Newly Installed Door to Provide Access to the Building for the Disabled**

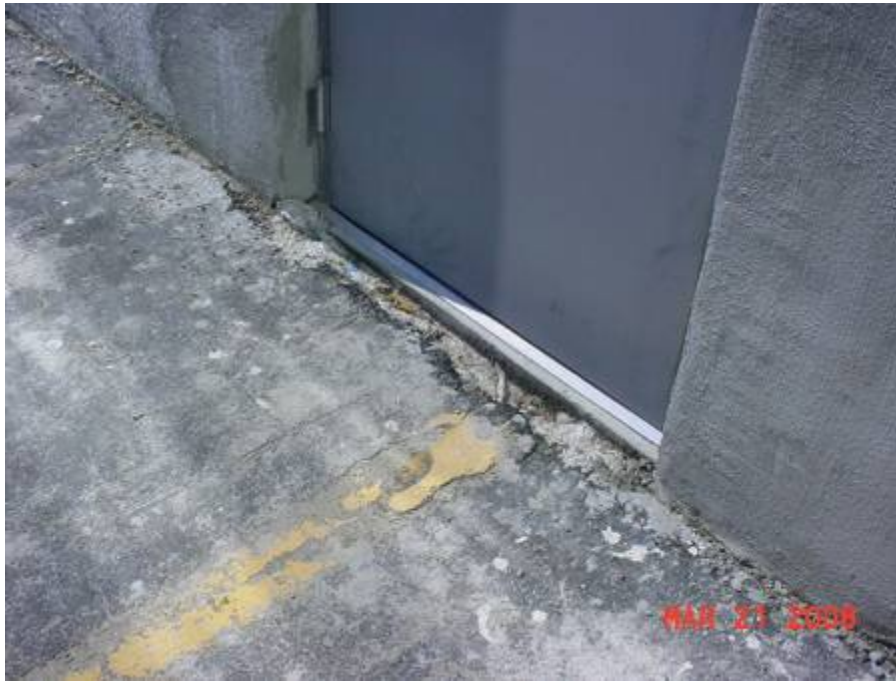
**Picture 4**

**Threshold of Door in Picture 3**

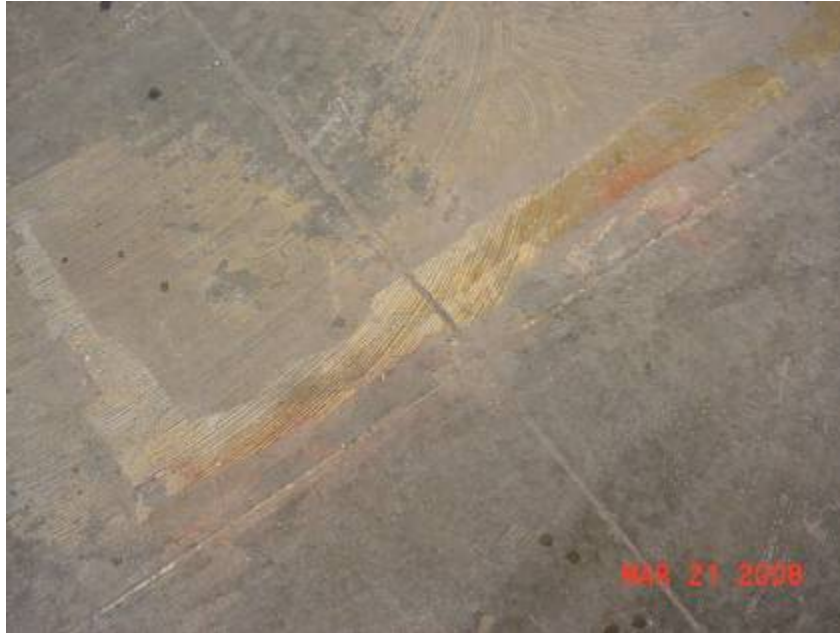
**Picture 5**

The floor of the office space is massive slabs with concrete-filled gaps (Picture 5). BEH staff could not identify any locations in the floor that would serve as a migration route for odors and/or moisture to travel into the occupied space from below floor locations.

**Cement Floor beneath Carpeting**

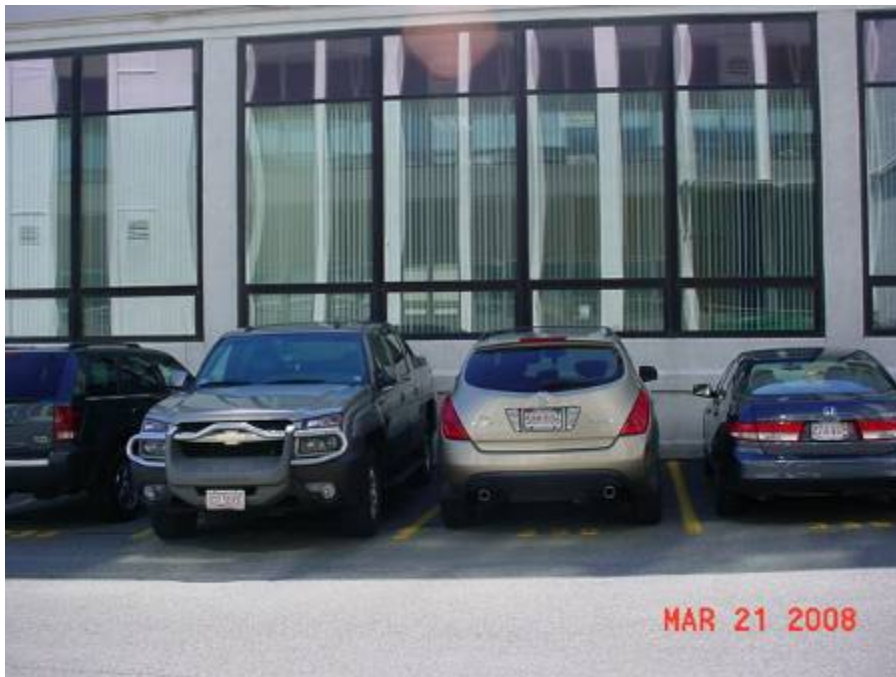
**Picture 6**

*Carbon monoxide should not be present in a typical, indoor environment.* If it is present, indoor carbon monoxide levels should be less than or equal to outdoor levels. Outdoor carbon monoxide concentrations were non-detect (ND) (Table 1). Carbon monoxide levels measured in the building were also ND (Table 1). While CO was ND, potential for vehicle exhaust entering the building exists due to the parking area located beneath office windows (Picture 6). Office windows should be kept closed to prevent this contingency.

**Parking beneath Office Windows**
